Project location: Kulangsu, Xiamen, China

Designer: Beijing Guowenyan Cultural Heritage

Renovation Workflow of Former Japanese Consulate in Kulangsu

Former Japanese Consulate in Kulangsu, Amoy, CHINA

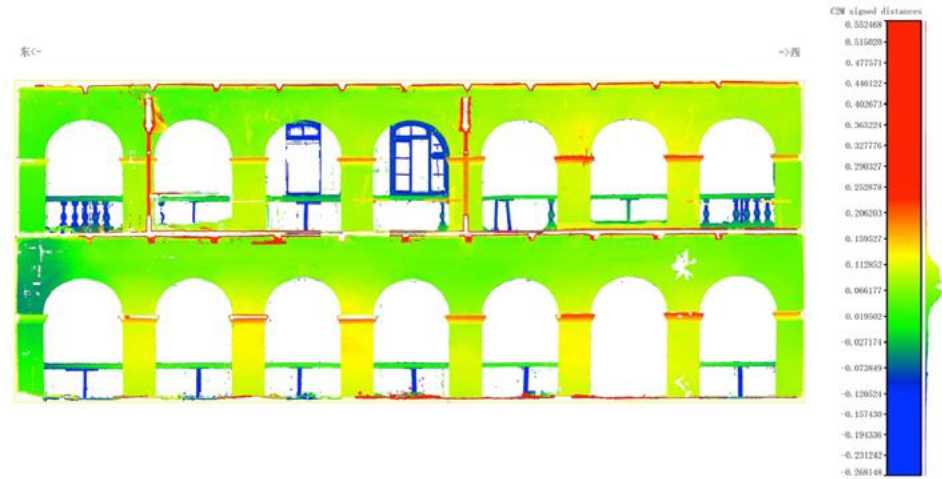
Analysis of the undulation of the south facade inside the building © CHCC

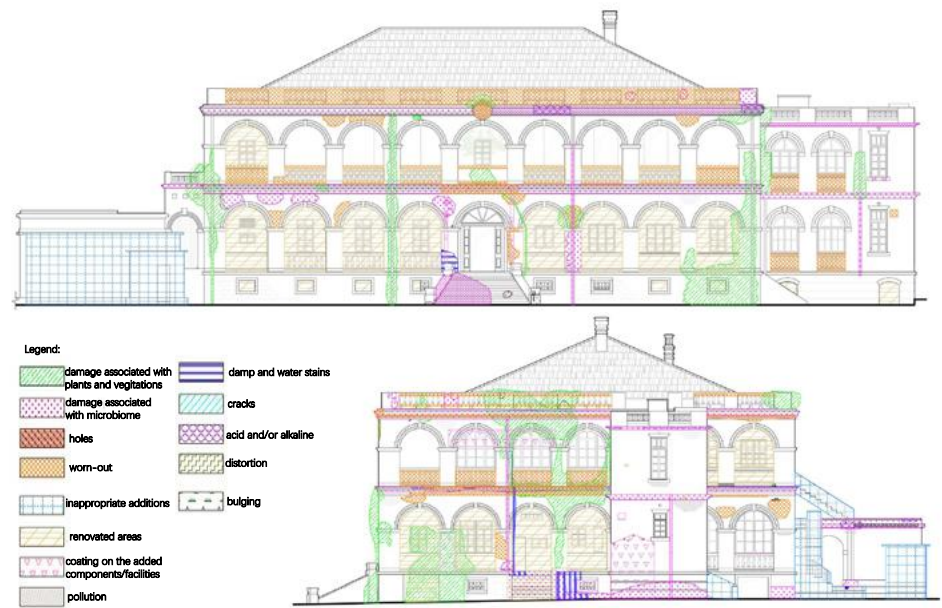
Analysis of the facade wall distress © CHCC

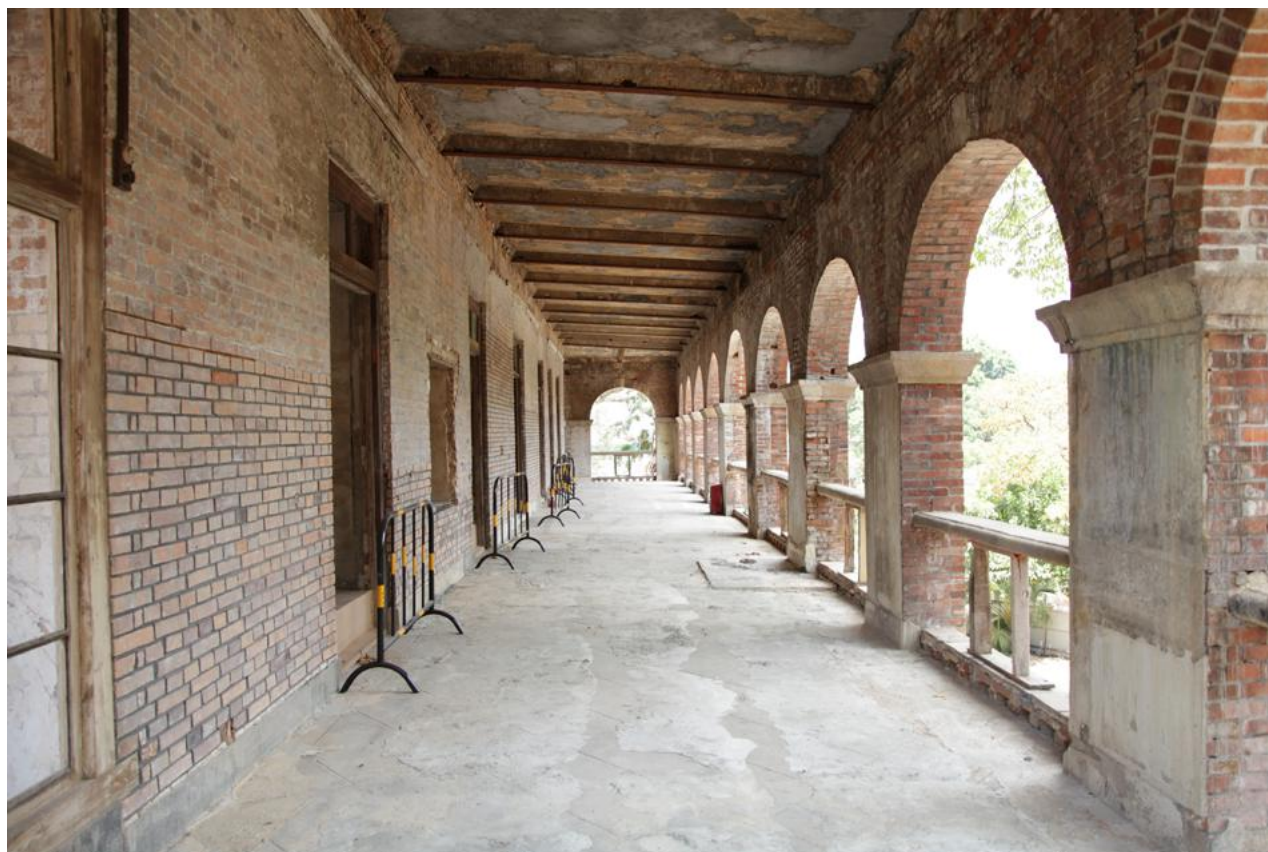
F/1 veranda under renovation © Zhang Guangwei

For the design of the veranda, an element of the typical characteristics, we balanced structural safety and the creation of a historical ambience. We reinforced the fair-faced brick walls through mortar replacement to continue the historical style. We strengthened the concrete slabs with laminates and restored the moldings strictly according to the historical style. After reinforcement, we added terrazzo flooring to the concrete floor to be consistent with the interior of neighboring buildings.

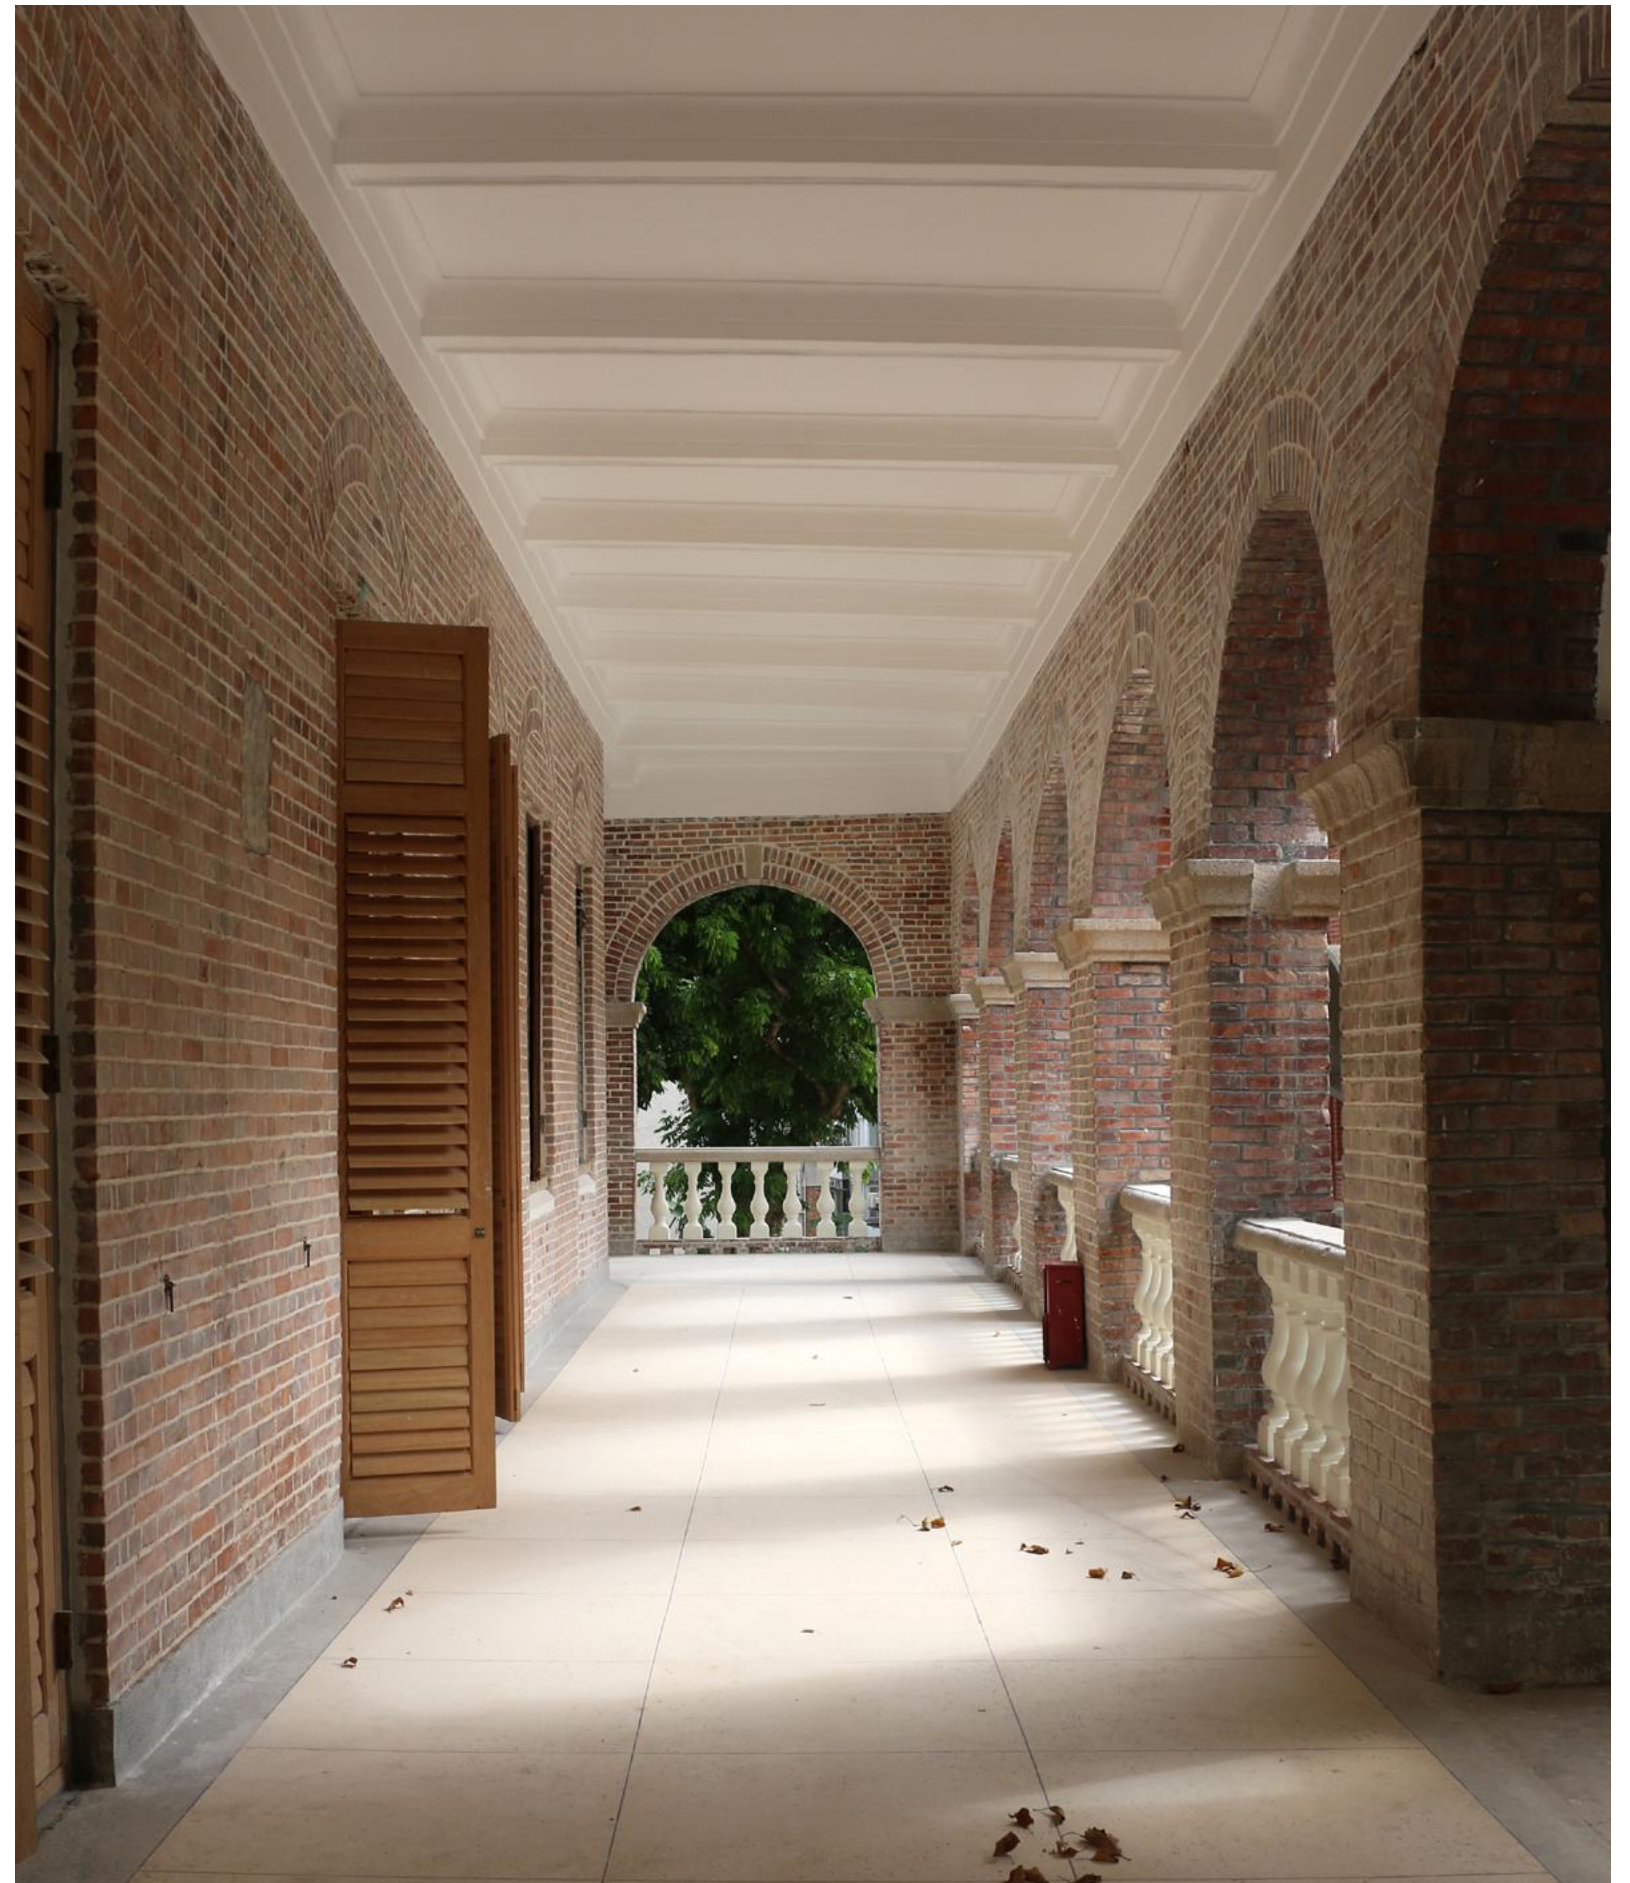
F/1 veranda after renovation © Zhang Guangwei

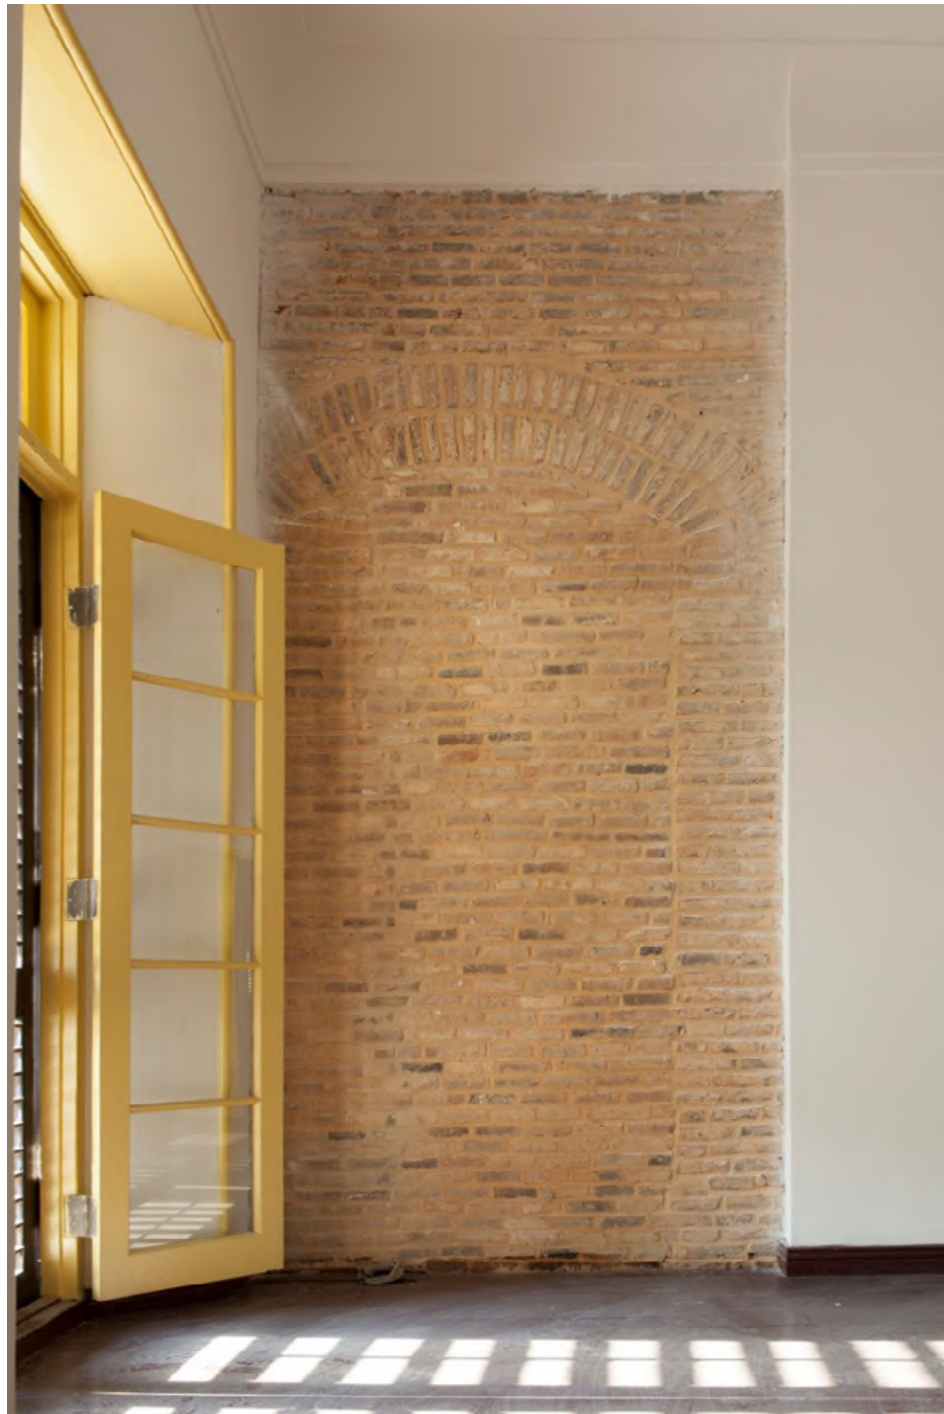
Door arch © CHCC

When treating the traces of earlier renovations discovered in the construction works, we selected the parts highly relevant to the historical drawings. We displayed them through structural reinforcement and construction instead of simply restoring them or covering the traces with plaster again.

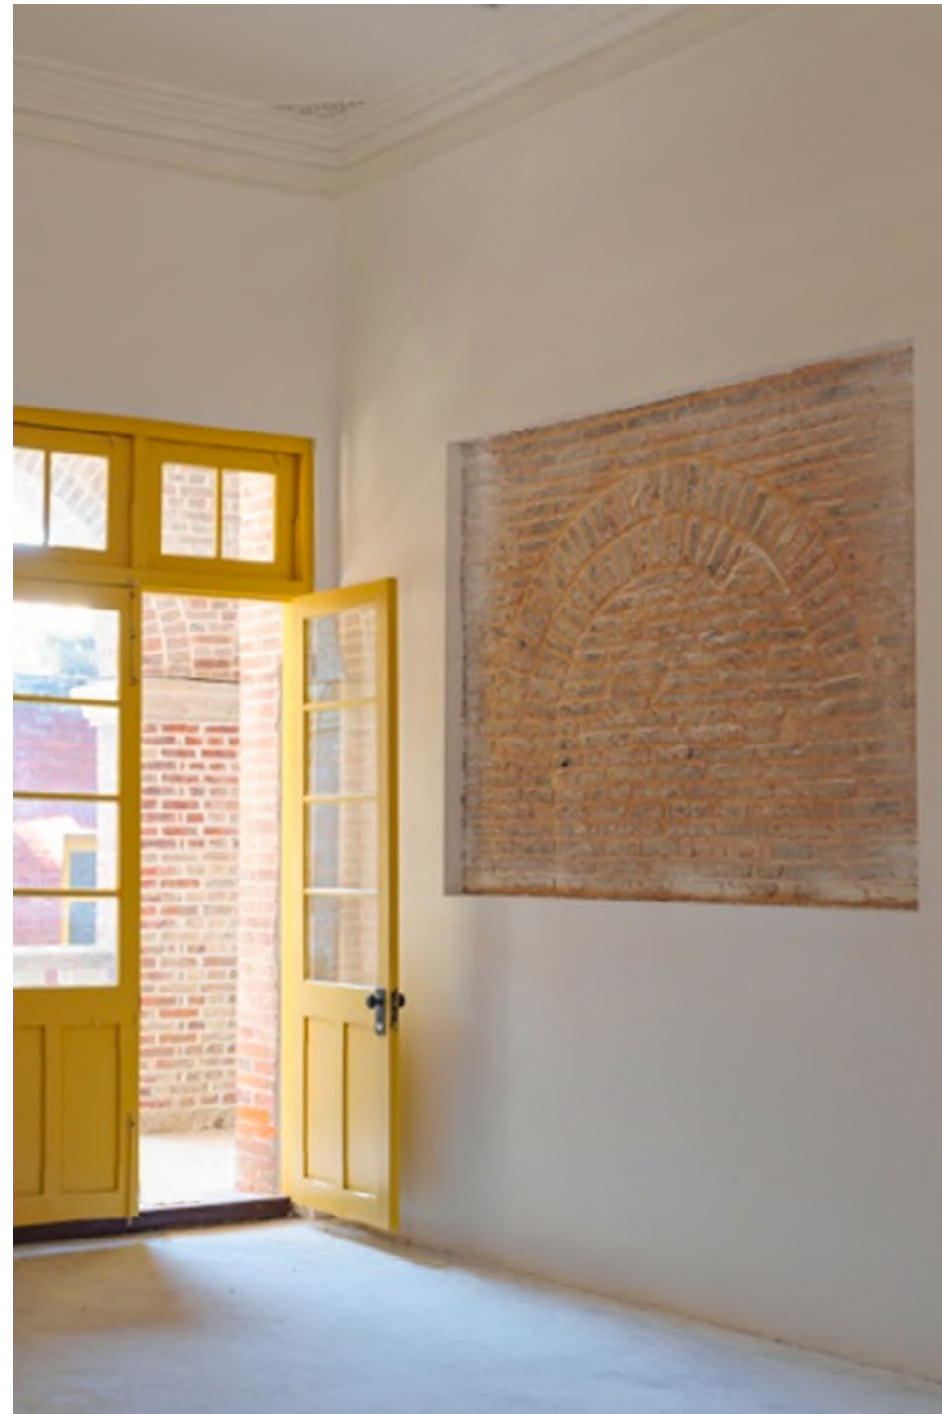
Arch at the food delivery site © CHCC

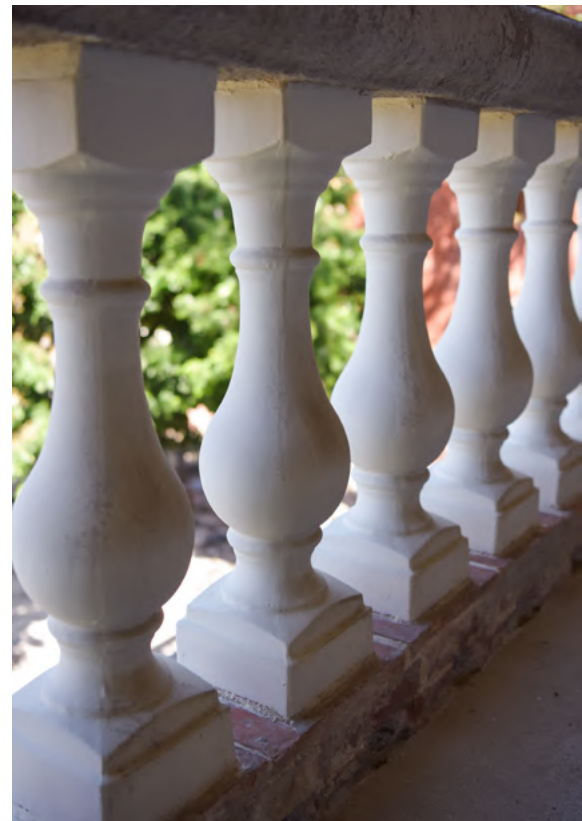
Renovated vase railings © Cheng Gu

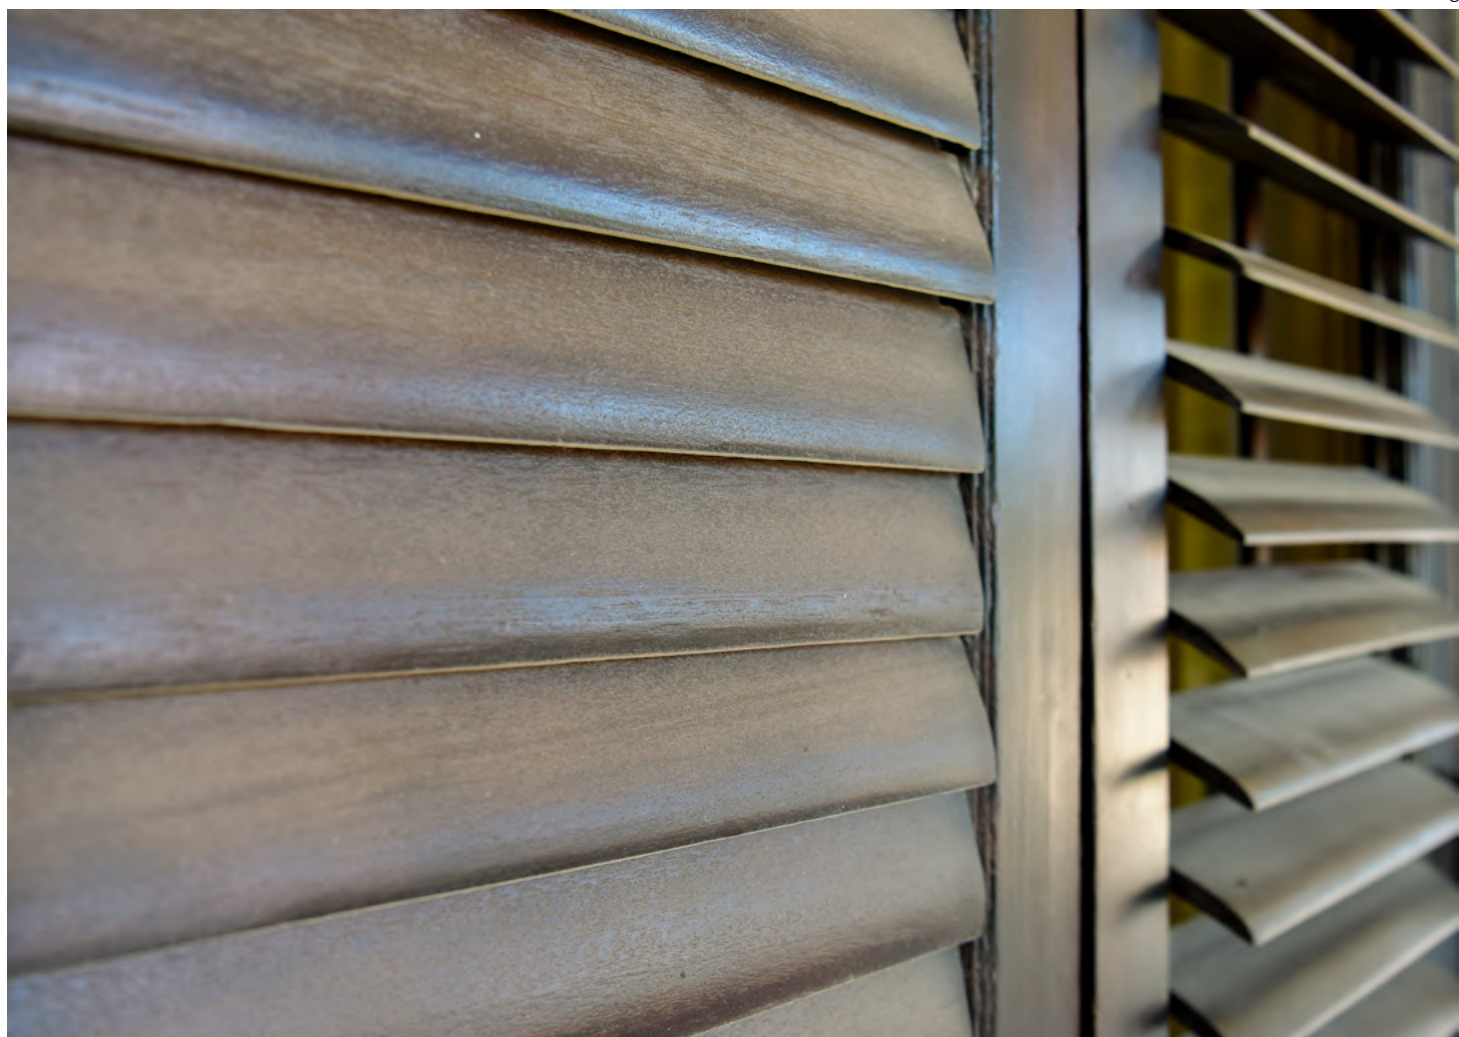
Renovated window shutters © Zhang Guangwei

To guide the implementation of detail design, we conducted research and scientific test on real objects to analyze the technologies and materials of bricks, tiles, doors, windows, timber, paint layers and hardware.
